FIELD REPORT

U2016 - 03

Assesment of Bridge Deck Membrane (BDM) System
Bridge 165 VT 100, Warren VT

Project Number – ER STP-0134(36)

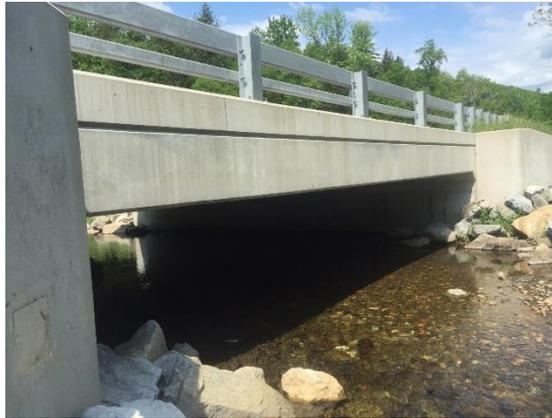
**Figure 1: Overall View of Bridge 165 on VT 100, Warren VT.
Right side of bridge facing south**

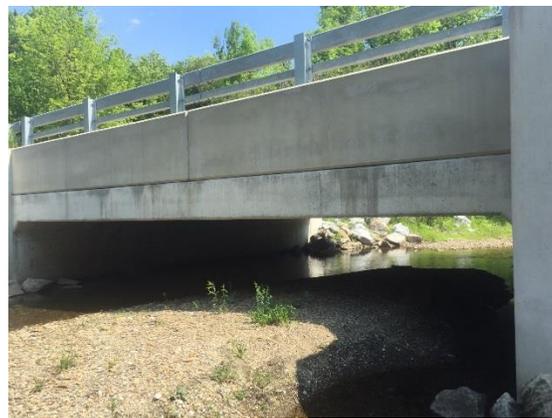
**Figure 2: Overall View of Bridge 165 on VT 100, Warren VT.
Left side of bridge facing north**

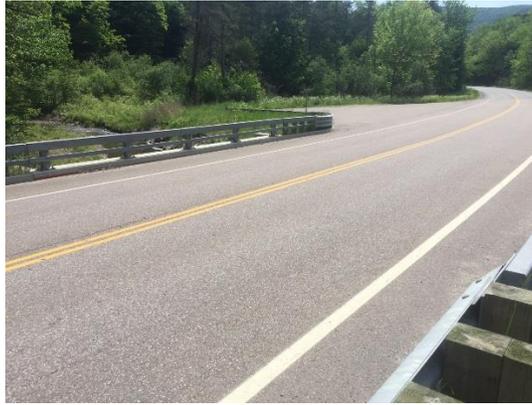
Figures 3 – 7 show longitudinal cracking on the bridge overlay. From the visual inspection and photographic evidence, it can be said that the BDM is working and at this point it is inconclusive if the membrane is contributing to the longitudinal cracking on the bridge deck. During the inspection I noticed that the longitudinal cracking was also occurring in the surrounding asphalt

Figure 3: Overall view of bridge overlay. Side view looking south.

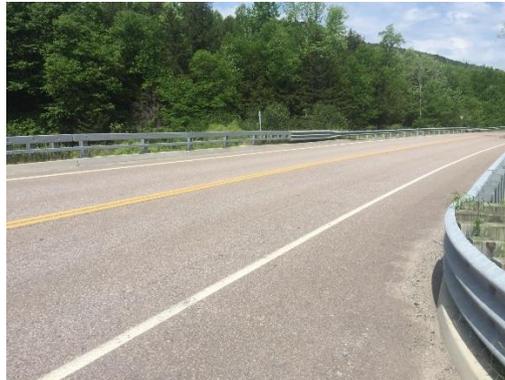
Figure 4: Bridge Overlay, looking north.

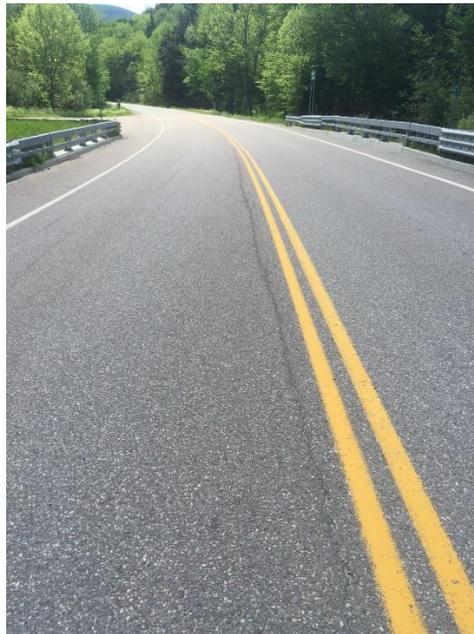
overlay, which means that the cracking could be attributed to the material properties of the asphalt overlay. While on the site visit it was noted that there was one longitudinal crack in the southbound lane and seven cracks on the northbound lane. The cracks ranged from approximately 3ft to 12ft. Figure 5 shows a centerline crack that runs the whole length of the bridge. Figure 9, which shows the underside of bridge 165, depicts some sort of white material seeping through bridge deck joints and cracks and depositing on the underside of the bridge. The depositing material is most likely chloride or salt from de-icing the roads during the winter season. In general the condition of the bridge deck is good and further studies in the bridge deck would have to be conducted to determine if BDM is contributing to the bridge deck cracking.

Figure 5: Centerline crack throughout bridge Overlay, looking south.

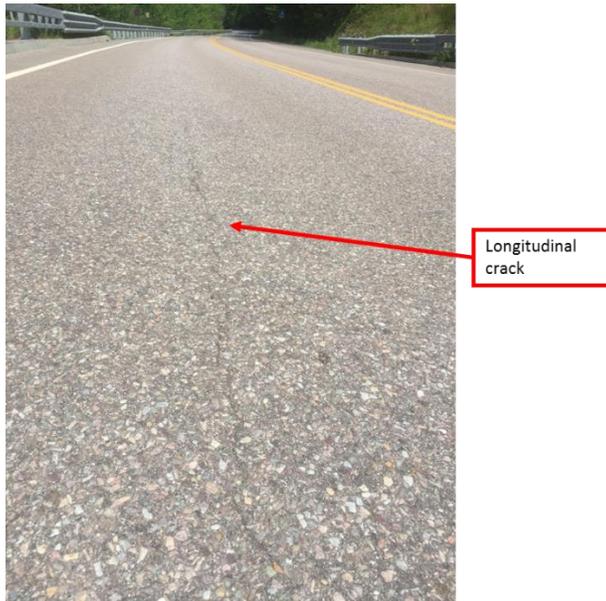
Figure 6: Longitudinal crack on southbound lane

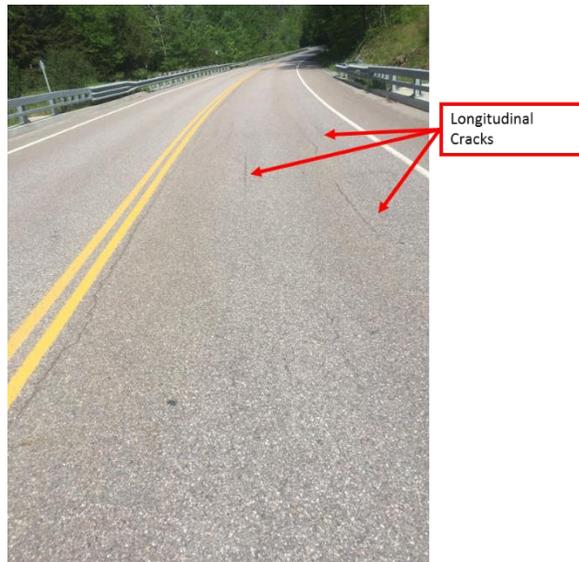
Figure 7: Longitudinal cracks on northbound lane

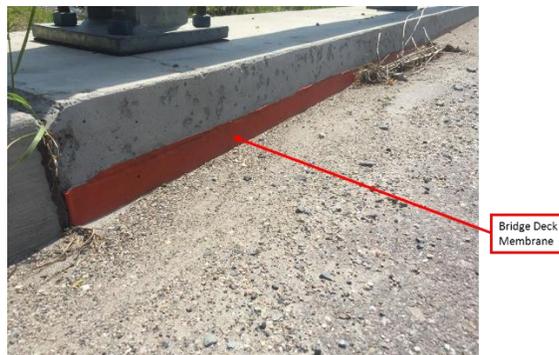
Figure 8: Bridge deck membrane

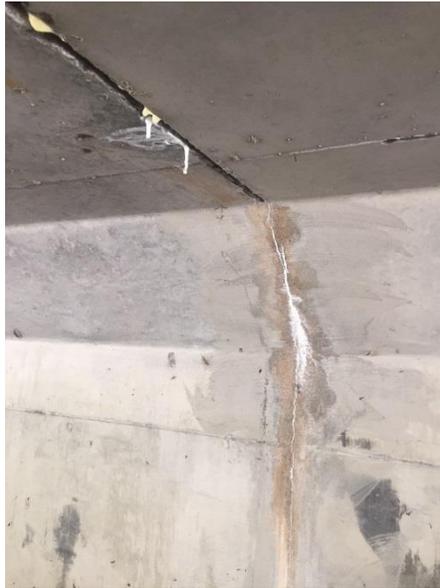
Figure 9: Bridge underside deposits
